# Manhole Inspection Summary

Manhole # S19Y\_\_025MH

**Location** Address: **1812 harman av** Cross Street: **washington-james alley**

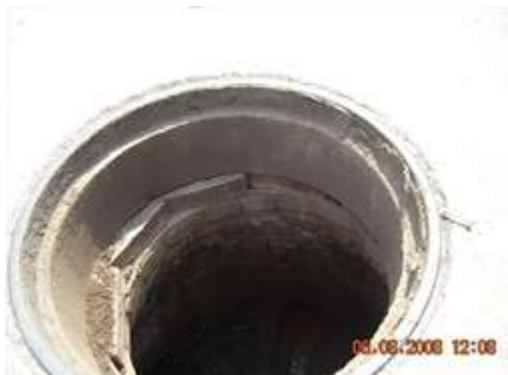
Misc.

**Manhole** Type: **Inline** Location: **Sidewalk** Ground Conditions: **Dry**  
☐ Prev. Rehab Weather: **Dry** Subject To Ponding: **Sheeting**

inflow evidence from sheeting

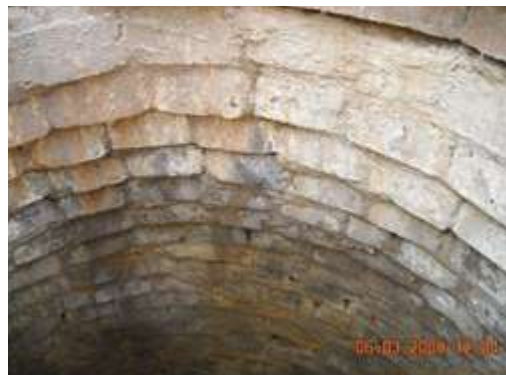
Defect 5

Infiltration: ☐ None ☐ Joint ☐ Cracks ☐ Mortar ☐ Roots ☒ **Wall**

infiltration @ corbel wall

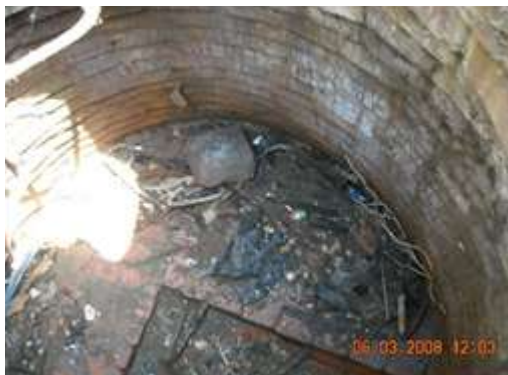
Defect 3

Condition: ☐ Sound ☐ Cracked ☐ Root Intrusion ☐ Deteriorated ☐ Leaks ☒ **Debris**

debris on bench

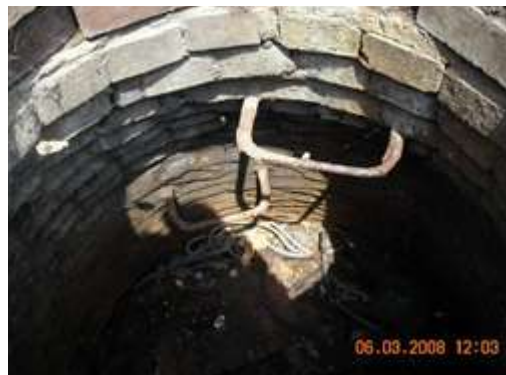
Defect 2

Condition: ☐ Sound ☐ Cracked ☐ Root Intrusion ☒ **Loose Brick** ☐ Deteriorated

**Steps** Count: **2** Missing: **0** ☒ **Corroded**

corbel loose bricks, corroded steps

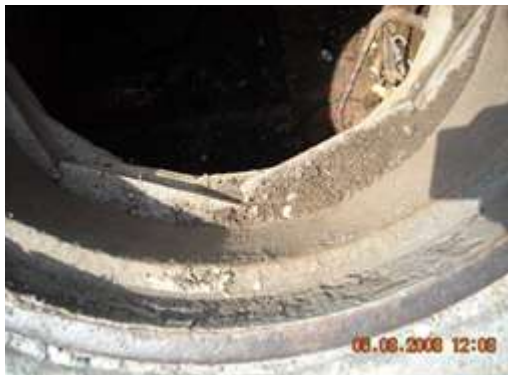
### Defect 1

**Frame** Offset: **1.5** (in.) Condition: ☒ Sound ☐ Cracked ☐ Leaks

frame offset

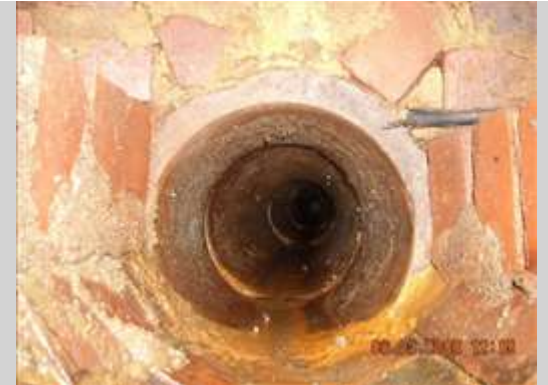
12 O'Clock Outflow

Pipe Height: **8.4** (in.) Rod and Bar (Angled)  
Pipe Material: **Clay** ☐ Pipe Lined  
Invert Depth: **5.72** (ft.) Flow Characteristics: **Slow**  
Deposits: ☒ None ☐ Mud ☐ Sludge ☐ Debris ☐ Grease  
Silt Depth: **0** (in.) Deposits Extent:  
Infiltration: **None** Pipe Seal Cond: **Sound**

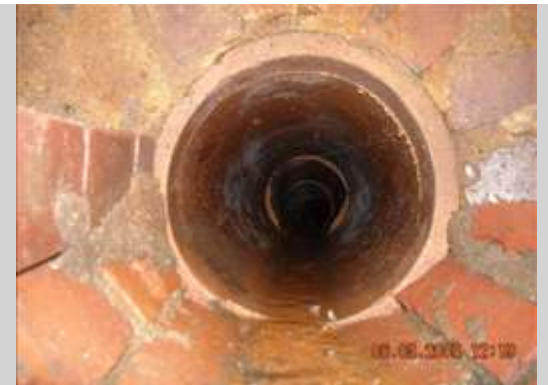
9 O'Clock Inflow

Pipe Height: **8.4** (in.) Rod and Bar (Angled)  
Pipe Material: **Clay** ☐ Pipe Lined  
Invert Depth: **5.20** (ft.) Flow Characteristics: **Slow**  
Deposits: ☒ None ☐ Mud ☐ Sludge ☐ Debris ☐ Grease  
Silt Depth: **0** (in.) Deposits Extent:  
Infiltration: **None** Pipe Seal Cond: **Sound**
